MISSED CORRECTIVE ACTION  
LEADS TO FAN BEARING FAILURE  
AND FIRE

A cement terminal in Cape Canaveral, Florida, uses a belt-driven dust collector fan as part of its site operations. The asset was monitored through Machine Sentry remote diagnostics to identify developing mechanical issues and give the site time to plan corrective maintenance before reliability or safety were affected.

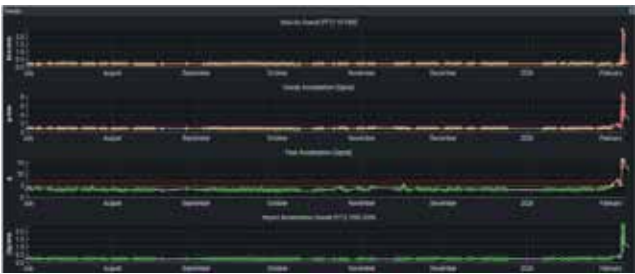
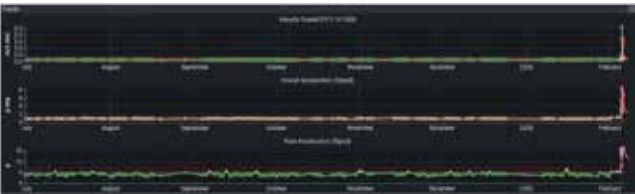
During routine remote diagnostics, an AVT Reliability Inc engineer identified elevated fan vibration indicating a potential imbalance.

Material buildup on the sheave was considered the likely cause, and a corrective action was raised recommending a sheave balance check and visual inspection.

The recommendation was not completed, and vibration levels remained above the asset’s normal operating range.

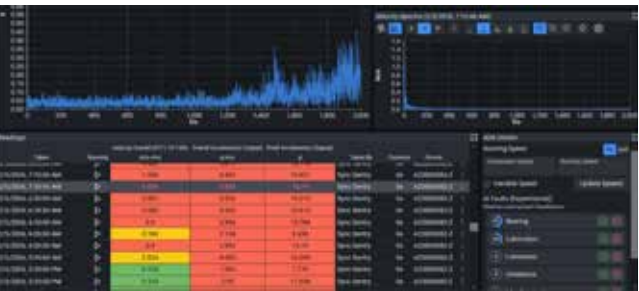
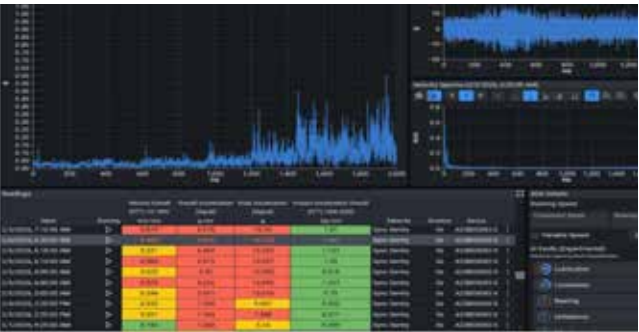
The fan bearing subsequently failed. During the root cause investigation, AVT Reliability reviewed the condition monitoring data with site personnel and confirmed that the automatic lubricator had been knocked off the bearing, resulting in inadequate lubrication.

As lubrication deteriorated, the bearing temperature increased until it eventually caught fire. Although correcting the sheave imbalance alone would not have prevented the lubricator from becoming displaced, completing the recommended inspection may have identified the issue before it developed into a bearing failure and fire.

When elevated vibration was first identified, the next planned shutdown provided an opportunity to:

- » Visually inspect the fan, sheave & surrounding components
- » Check for material buildup on the sheave
- » Confirm whether an imbalance condition was present
- » Complete the recommended corrective maintenance
- » Inspect the bearing lubrication arrangement and automatic lubricator
