# FAILURE ON LFG BLOWER AT LANDFILL SITE

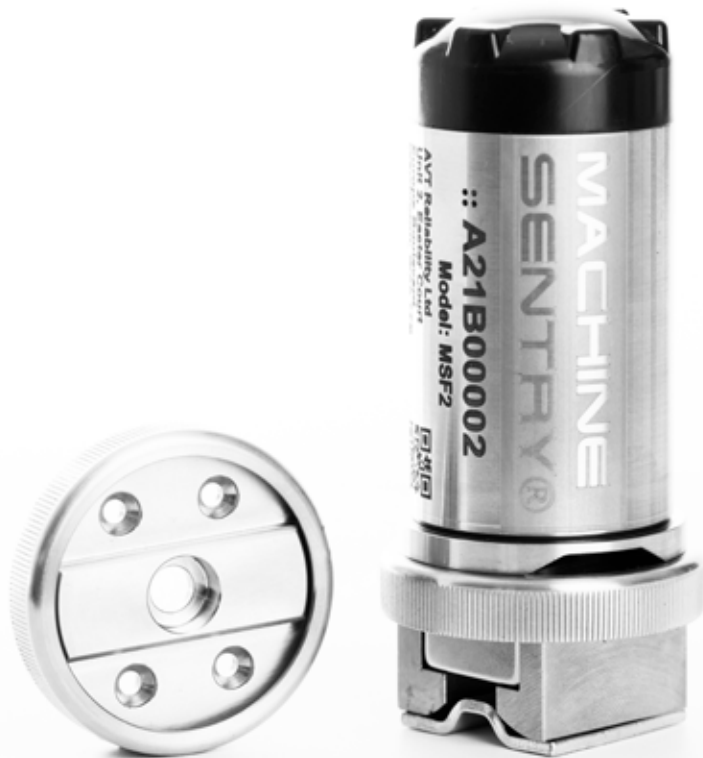
## MACHINE SENTRY FIXED (MSF2)

The MSF2 can be used on a wide range of equipment, including compressors, pumps and motors as part of a condition monitoring programme.

- Frequency range of 1Hz to 8.5kHz
- Internal memory large enough to store more than 5000 readings
- High-speed data transfer via Bluetooth®
- Programmable data acquisition
- Replaceable battery
- Up to 5 years battery life
- Gas zone 0 and dust zone 20 certified
- Sealed to IP 67

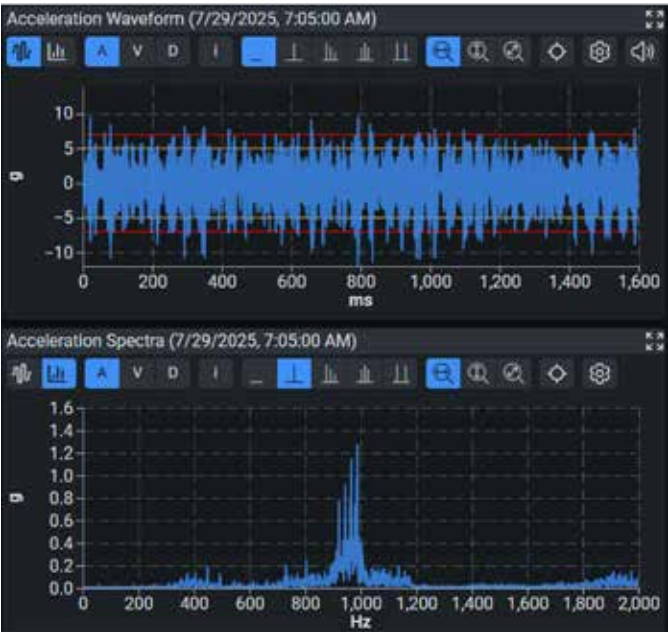
Blower 3 NDE Bearing

During a survey in July, one of the blowers showed early warning signs of a developing issue. Vibration levels were elevated at both the non-drive end (NDE) and drive end (DE) blower bearings. The frequency spectrum displayed high-frequency peaks unrelated to normal running speed, with an increased vibration floor separated by cage frequency. These indicators strongly suggested a bearing-related defect.

Temperature readings also raised concern. A 20 percent increase in temperature was recorded at the NDE bearing over just two days, further signaling that the component was deteriorating.

To validate the concern, the team compared the data from this unit (Blower 3, in service for two months) to a similar unit (Blower 2) that had been running for 12 months. Blower 2 showed stable performance, while Blower 3 exhibited the abnormal patterns.

An inspection of Blower 3 confirmed premature wear on the NDE bearing. Given the short time the unit had been in service, the most likely cause was a problem during installation. Shaft alignment was checked and found to be within acceptable tolerances for a 3,575 RPM blower, which ruled out misalignment as the root cause.

The equipment manufacturer agreed to replace both bearings under warranty. As part of the corrective measures, the oil reservoir was cleaned and refilled, and the lubrication schedule was updated to better support blower performance. Thermal insulation was also added around the bearing housing to reduce the effects of ambient temperature fluctuations.
